EM-ISight
Test Applications Using an Automated Near Field
Detection System

Case Study 1 Netbook

Case Study 2 (tablet)

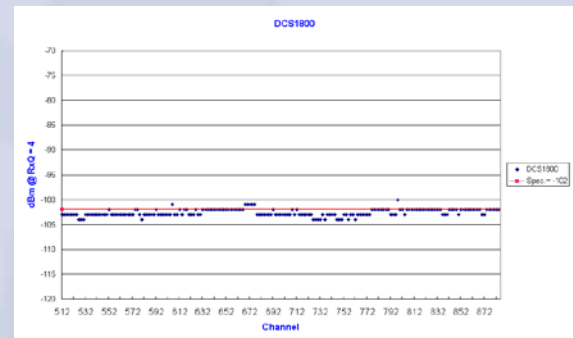
Failed Results

Pre-compliance assessment of device in OTA total isotropic sensitivity failed.

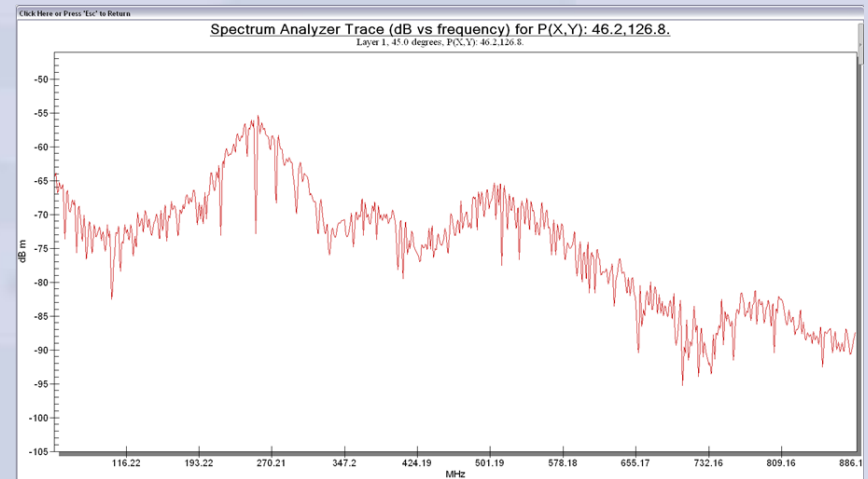
Factor of 2 Lower

Typical measurements for spurious have a significantly higher noise floor than those which we use to find a noise source that will effect a receivers sensitivity.

For this type of analysis we would not use an Open Area Test site. Even some 10M chambers have a noise floor greater than what is required.

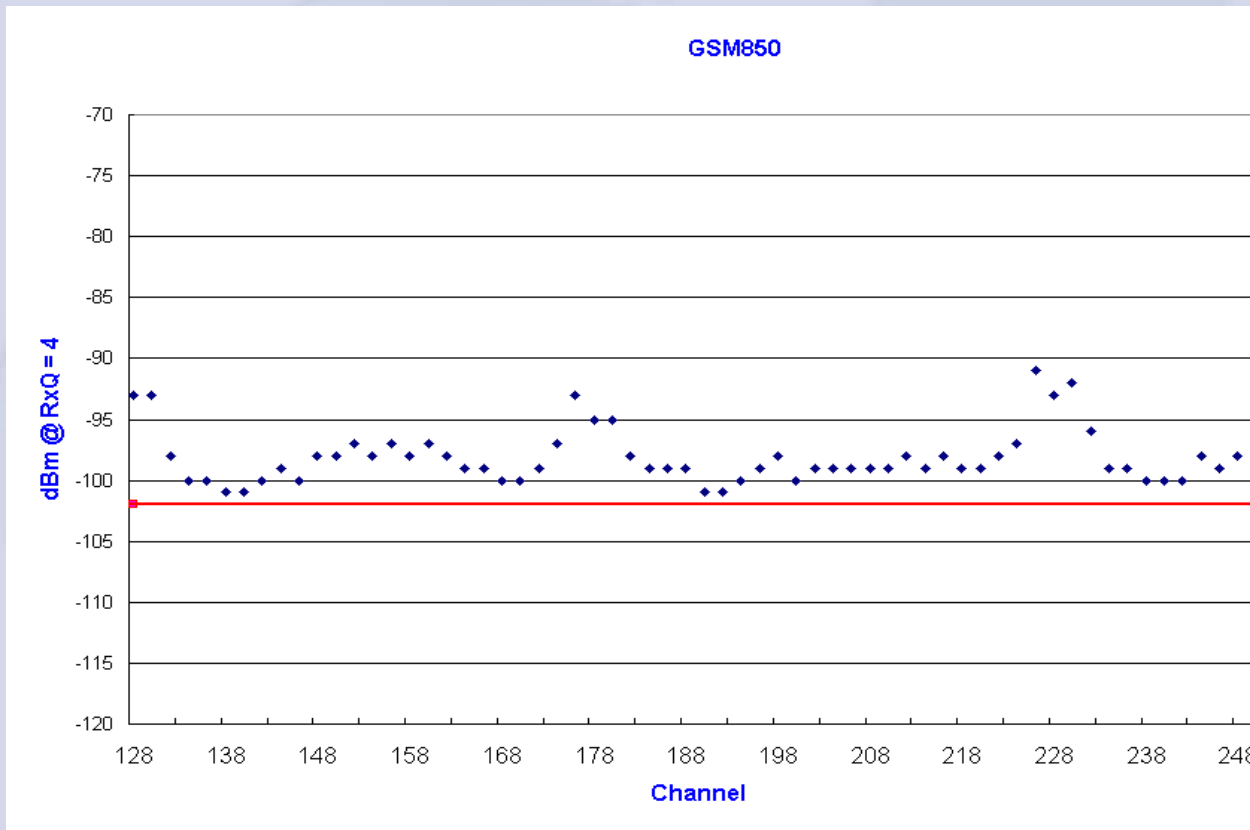
869MHz-894MHz Uplink

Case Study (Cellular 850 data)

- Cellular 850
- PCS
- The failure means PTCRB for WWAN would not pass TIS (Total Isotropic Sensitivity)
- Further analysis of potential noise source to be initiated
- Determine the fundamental frequencies of noise source

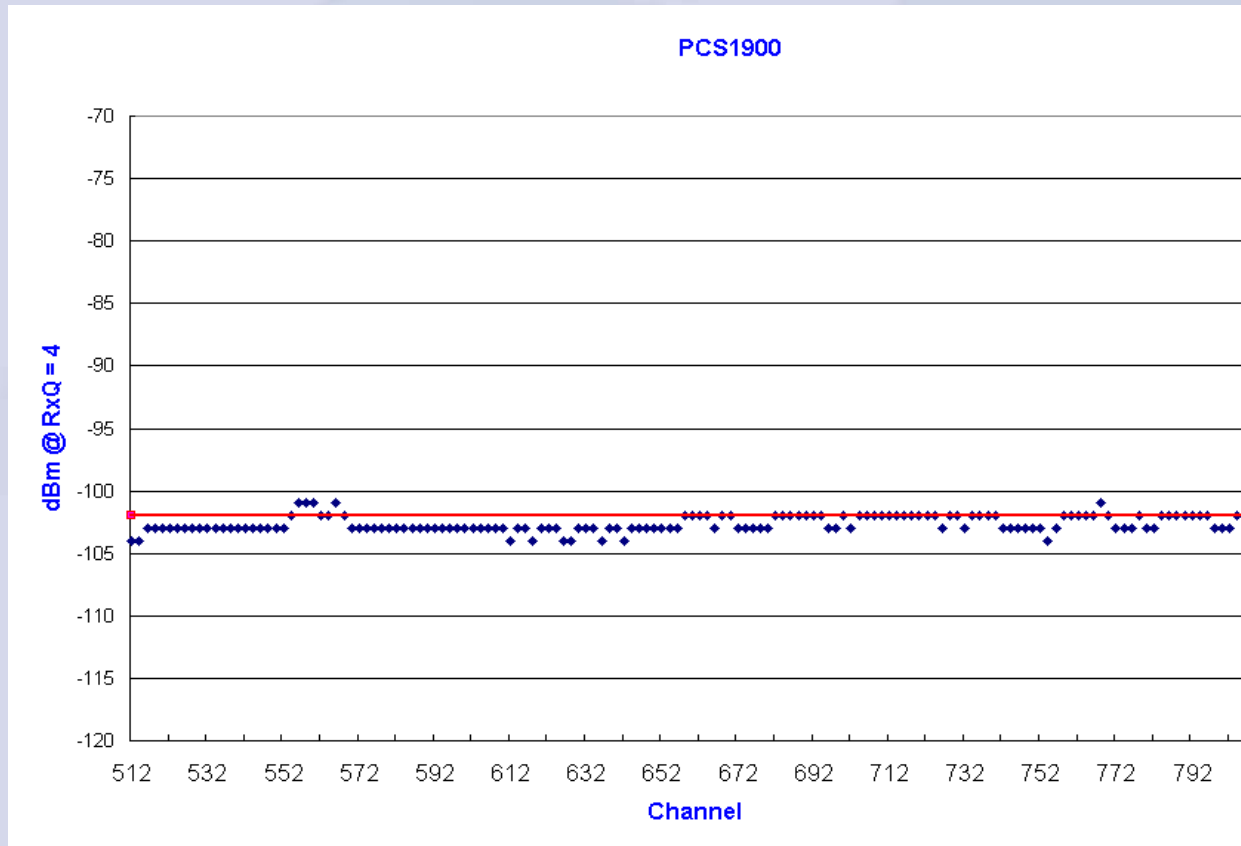
1930MHz-1990MHz Uplink

Case Study (PCS data)

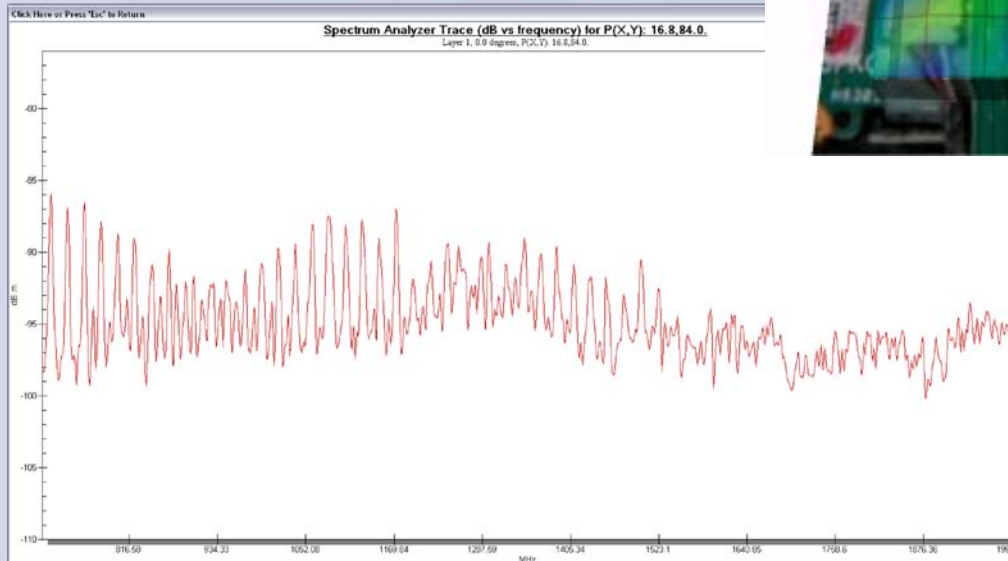
Dual Flex Connector (3)

Unintentional 1574MHz
Measured = -129dBm
Could be LVD 22nd Harmonic

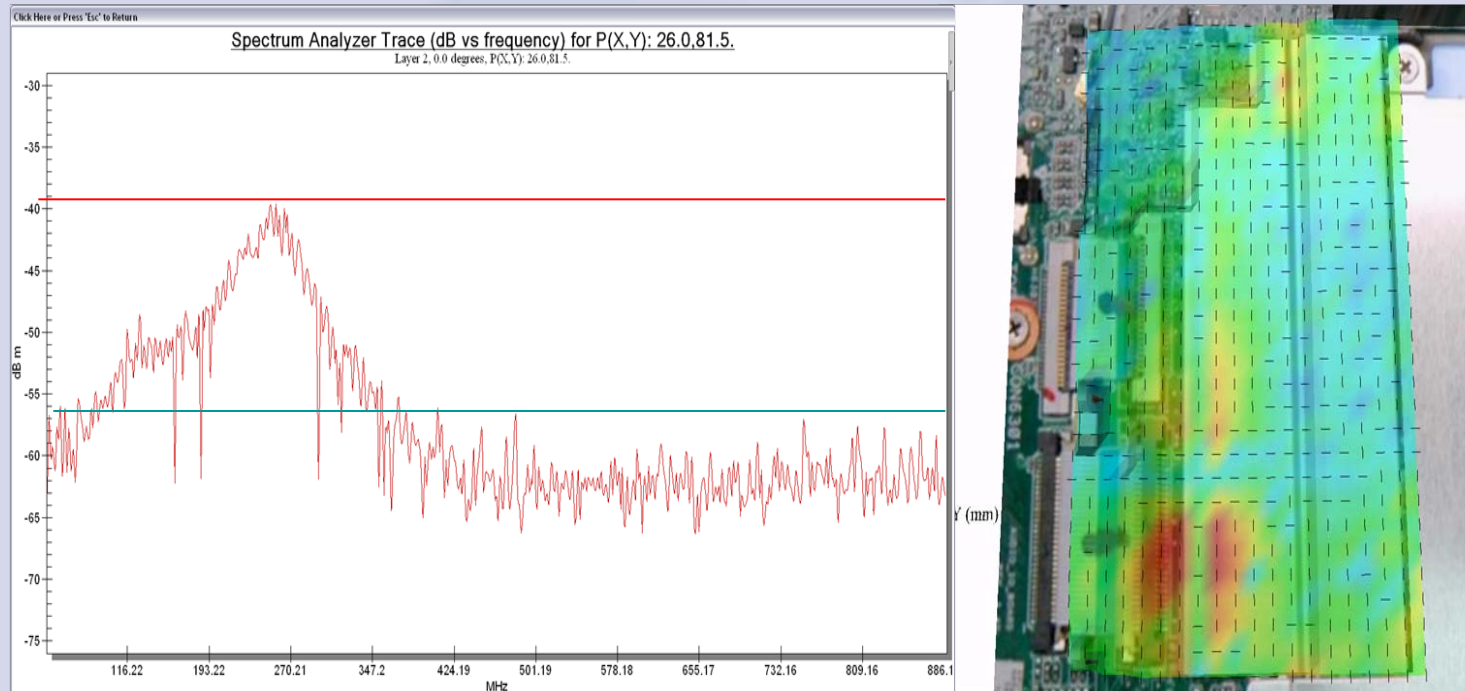
Shield Effect

Dropped the second and third harmonics by 22dBm
Shifted the fields away from the GPS/Wireless location

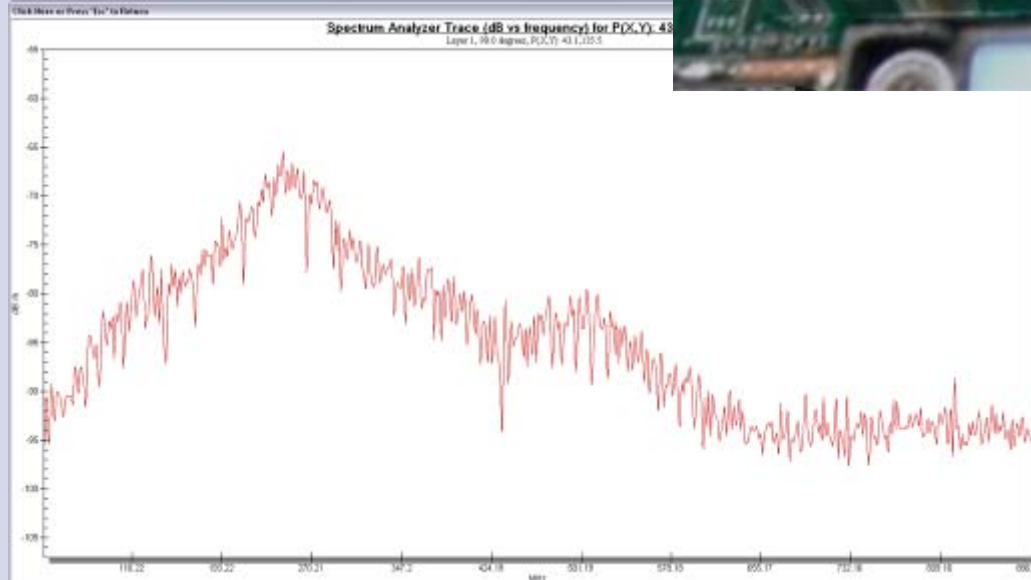
GPS Circuit (6)

Fundamental = 260MHz
Peak = -100dBm
Second Harmonic = -115dBm
Third Harmonic = -125dBm
Noise Floor = -135dBm
